# SEM analysis reveals real cause of chip failure

*Trouble-shoot problems quickly to save time*

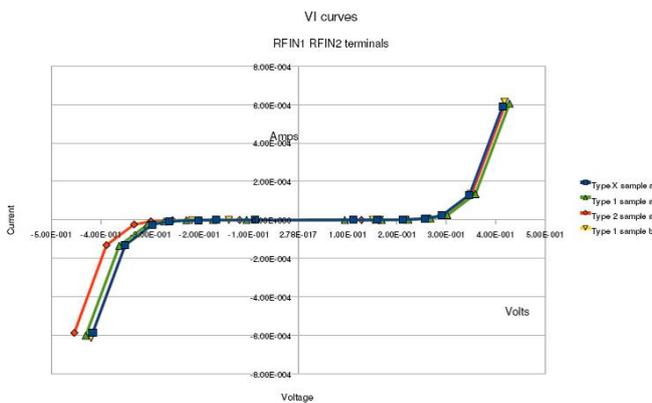
The obtained results showed, however, quite a different VI characteristic. All three types showed the same VI-curve which is similar to one of an anti-parallel Schottky diode (see fig. 3).

FIG. 3 Obtained VI-curves for the three design variants.

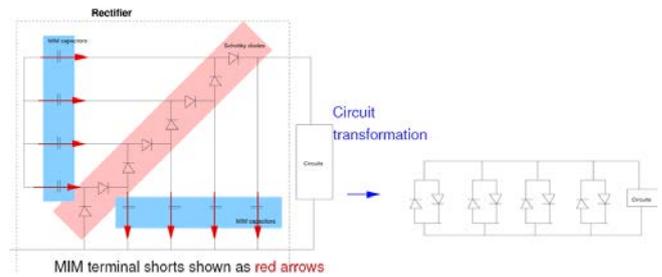
The design team discussed these results and came up with a possible explanation. What if - for some reason - the MIM capacitors are shorted<sup>1</sup>? Then - in this case - the rectifier circuit would transform to anti-parallel Schottky diodes (see fig. 4).

FIG. 4 Shows how the circuit will be if the MIM capacitors are shorted.

A simulation based on this theory was run and resulted in a curve similar to the obtained VI characteristics.

Therefore, shape and magnitude of the curves suggest that MIM caps are shorted.

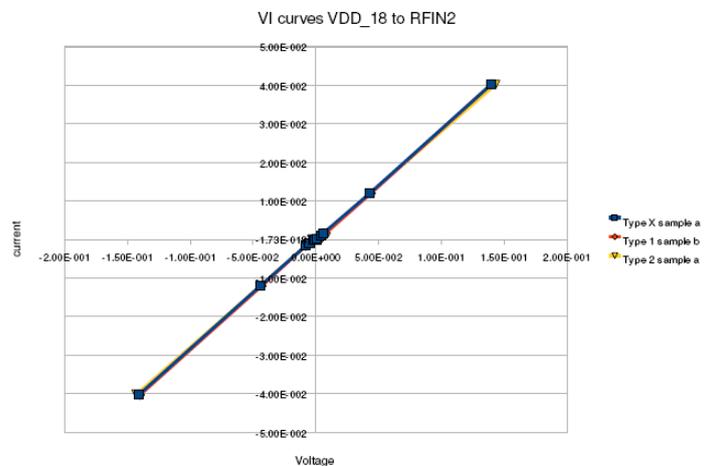
However, again here the actual results were surprising. For all 3 types the obtained results indicate a short between VDD18 and RFIN2 (see fig. 5).

FIG. 5 Obtained VI-curves between VDD18 and RFIN2. Resistance for all three variants is about 3.5 Ω.

Fig. 2 shows that there is a MIM decoupling capacitor between VDD18 and RFIN2. Again a short of this MIM capacitor will explain the obtained results of measurements on the prototypes.

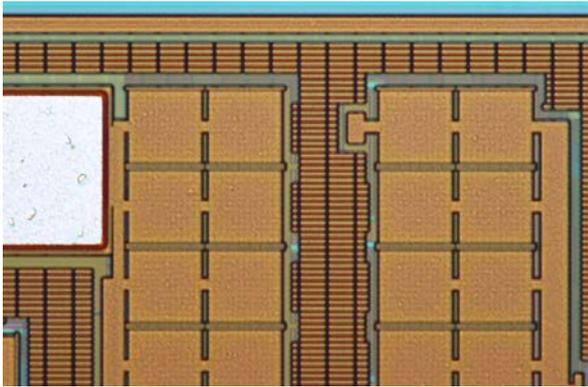
One die was then inspected optically but with no indication of process irregularities (see fig. 6).

FIG. 6 Optical micrograph showing part of the MIM capacitors.

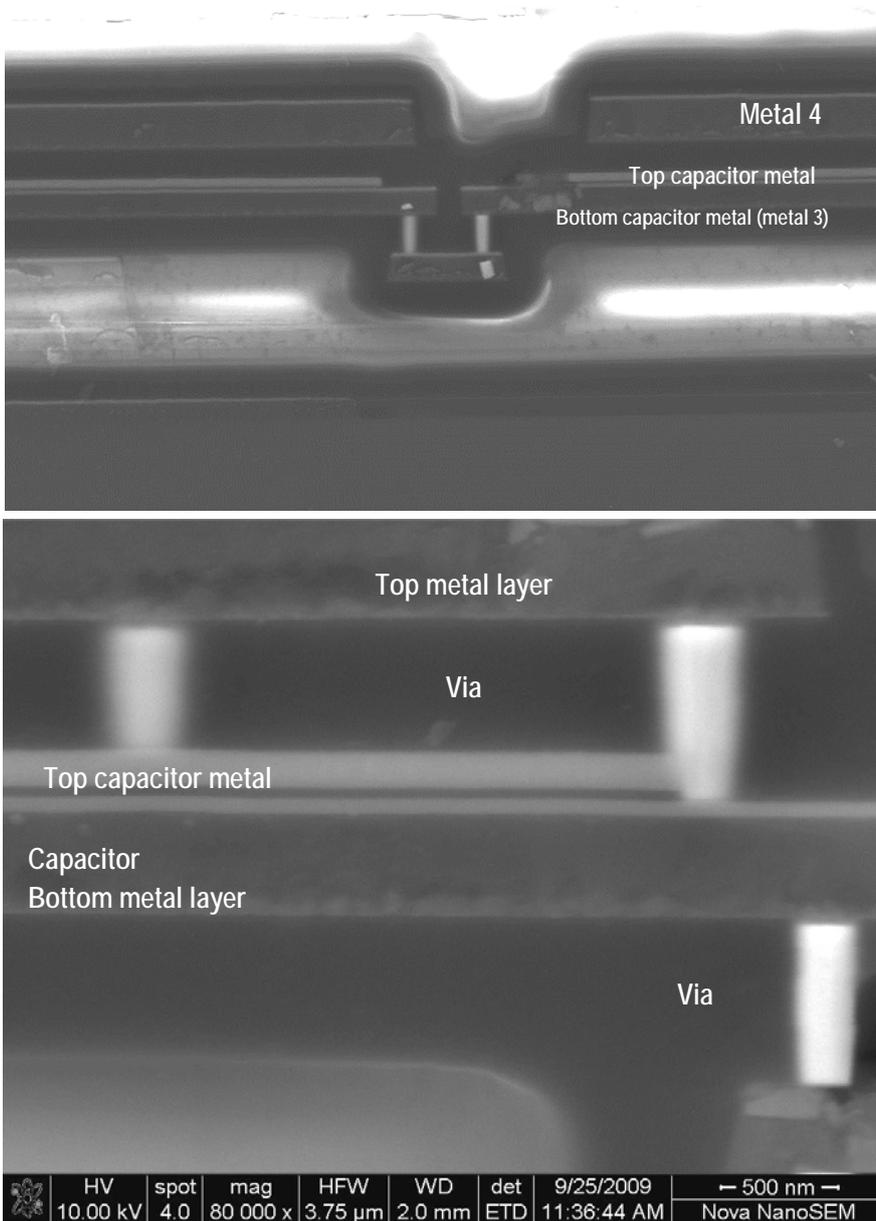
This investigation showed that the top metal layer (metal 4) was slightly misaligned – a little less than 1  $\mu\text{m}$  shift. This small misalignment caused a short in the MIM capacitors as one tungsten via - that should connect to the capacitor top metal - connected to the capacitor bottom layer (metal 3) (see fig. 7).

FIG. 7 SEM micrographs showing a cross-section of the MIM capacitor. Upper side view of the centre of the capacitor. The top metal layer is shifted to the right.

The micrograph below is an enlargement of part of the capacitor showing how the outer via is connecting to metal 3 instead of the top capacitor metal, thereby shorting the capacitor.

The results of this SEM evaluation were communicated to the wafer fab who immediately initiated a new wafer run.

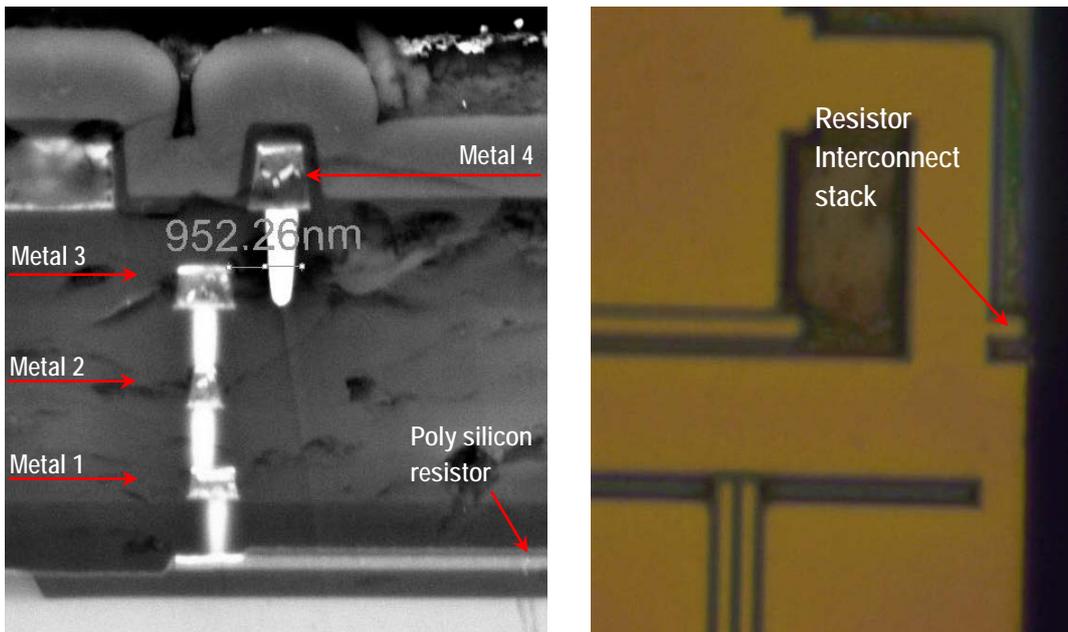
The small misalignment of metal 4 also explained another issue found during the debug of the prototypes. The performed electrical measurements pinpointed a poly silicon resistor (fig. 1 – type 1 and X) to be open/not processed.

A cross section through the resistor showed that metal 4 had no contact to metal 3 as intended (see fig 8).

FIG. 8 On the right the position of the cross-section relative to the poly silicon resistor is shown. On the left the missing contact between metal 4 and 3 can be seen on the SEM micrograph.
