X-ray detects hidden failure modes

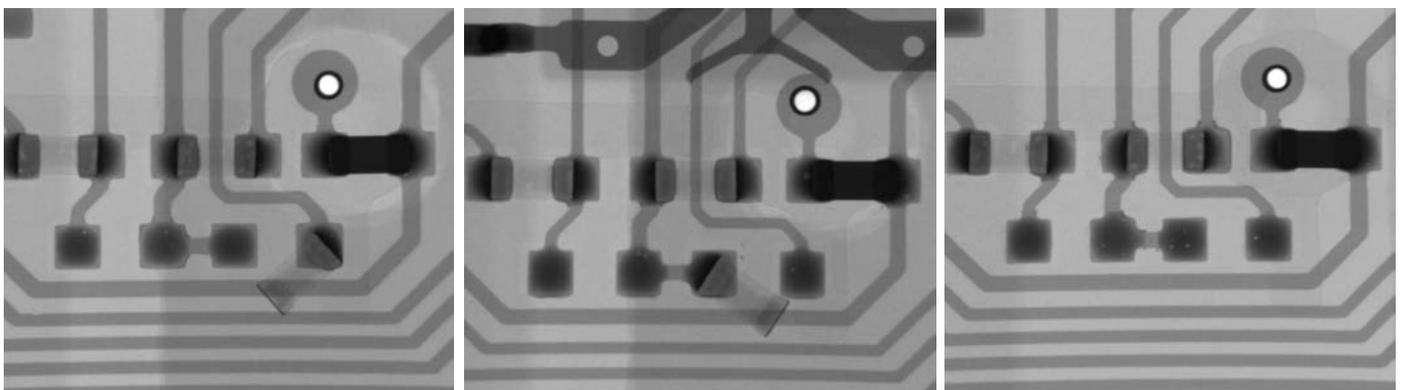
To maximise speed of reaction, DELTA decided to employ X-ray inspection as the first step in the failure analysis procedure. Real-time scanning of the suspect PCBs located the problem almost instantly - showing it to be an assembly error, caused by component displacement or a missing chip resistor in a specific area of the PCB (fig. 1).

FIG. 1 X-ray view of three PCBs, highlighting misplacement and/or a missing chip resistor.

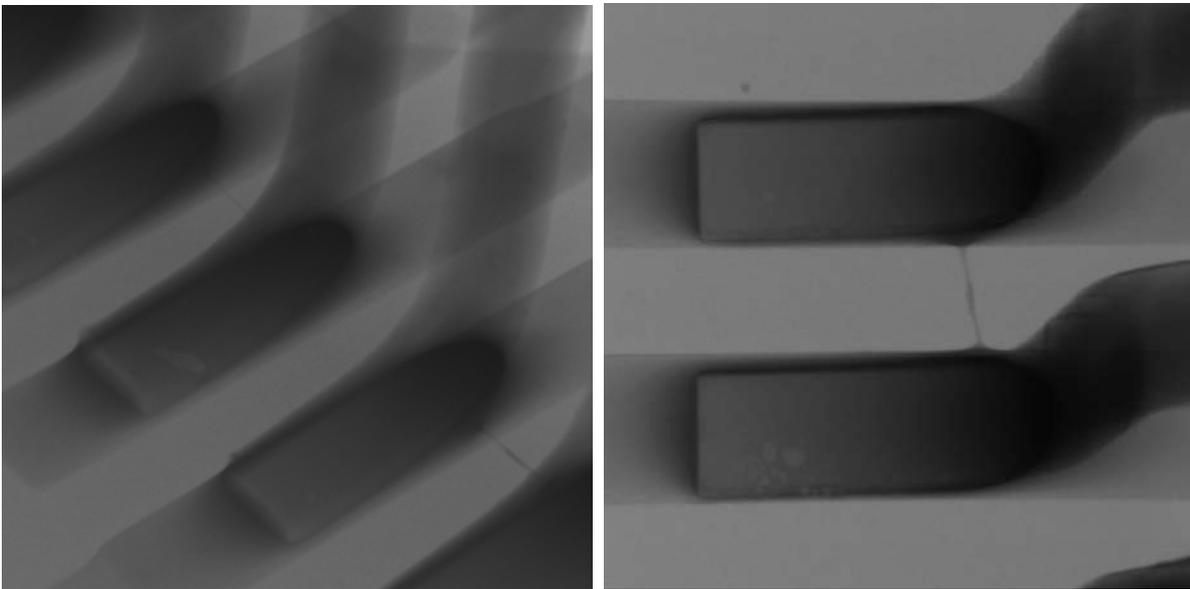
So, the PCBs were subjected to high-magnification and high-resolution X-ray examination. This quickly identified the cause of the failure as short circuiting between the very narrowly-spaced external connections of the QFP caused by 'tin whiskers'.

These defects were later found by careful, high-magnification optical microscopy. The short circuits were so fine that they were almost impossible to see during routine inspection due to their size, viewing difficulties and masking by flux residue (fig. 2).

FIG. 2 X-ray showing tin whisker short circuit tracks between the external leads of a large QFP package..
