Hidden solder joints inspected non-destructively

Less space introduces new failure modes which cannot be inspected visually

Quality concerns – 4 case studies

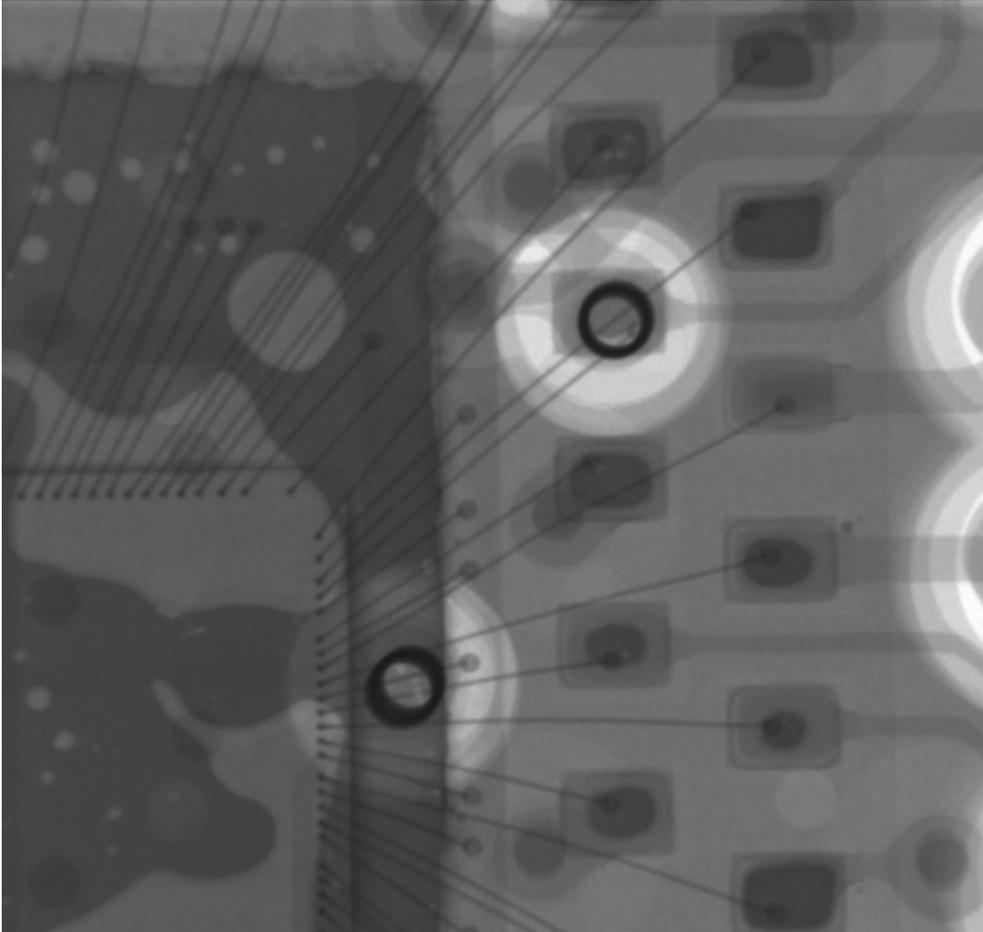
inspection clearly pinpointed insufficient solder paste on some pads to be the problem (fig. 1), which may have been caused by too large a sphere size in the paste used. On some boards, solder splashing was also observed (fig. 2).

FIG. 1 X-ray micrograph showing a dual QFN package assembly. Missing or insufficient solder paste can be clearly seen on some pads. Excessive voiding is also visible on the soldering of the exposed pad in the middle of the package.

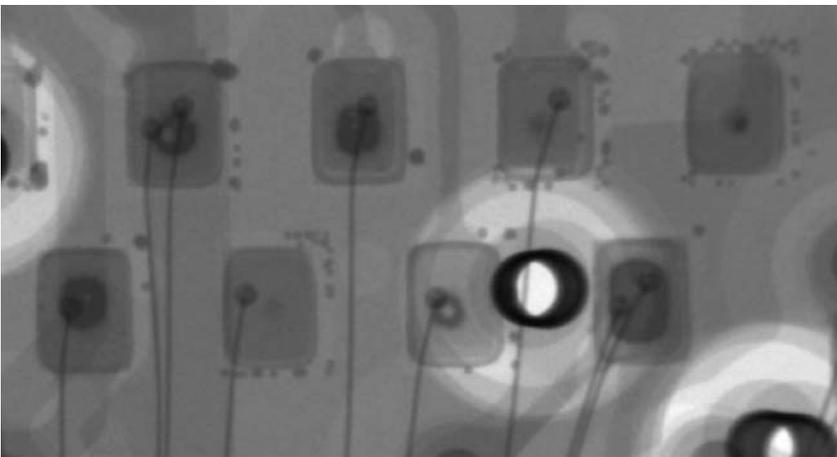
FIG. 2 X-ray micrograph showing an example of the solder splashing.

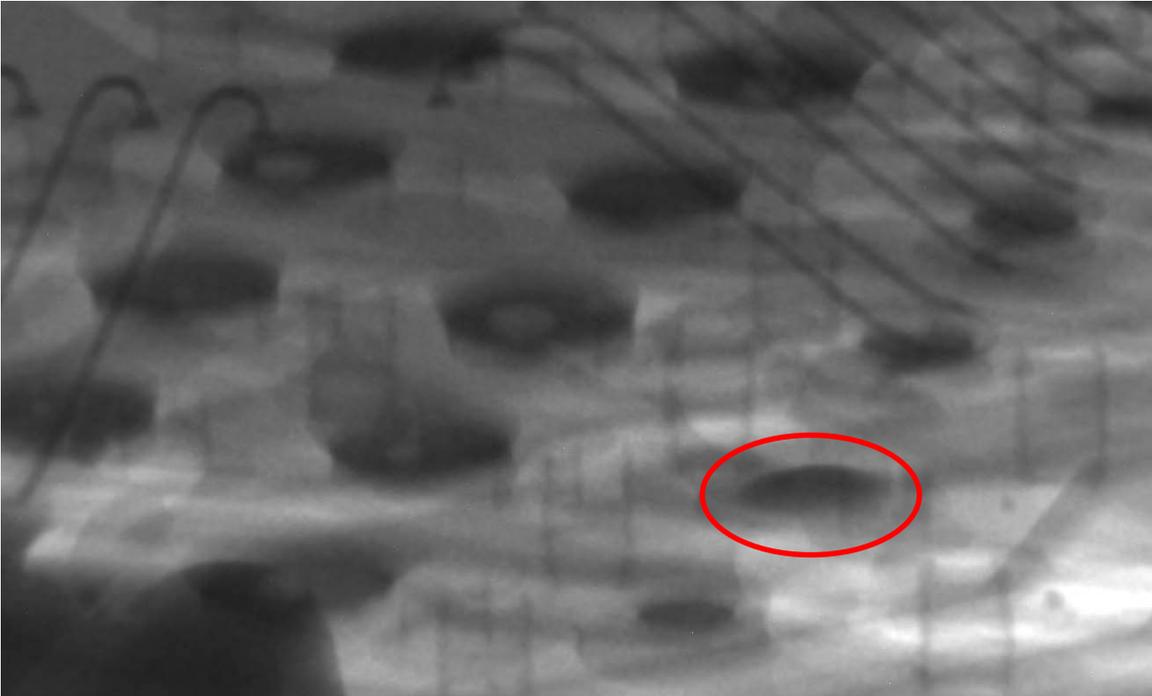
ate whether the assembled prototypes could be delivered to the end customer. It was found that in general, the solder paste amount was insufficient and varying, and for some connections this resulted in component pad non-wetting (fig. 3).

FIG. 3 View showing component pad non-wetting caused by insufficient solder paste.

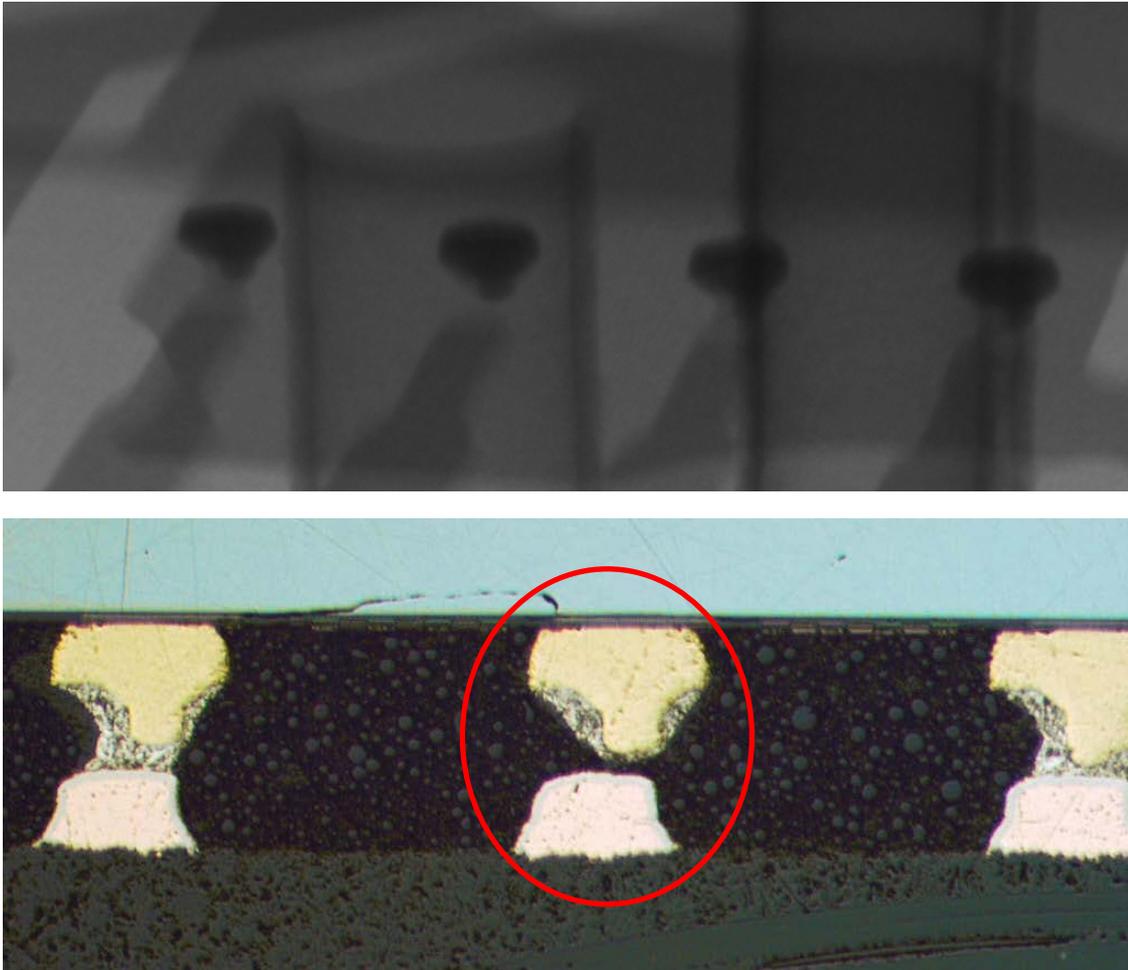
DELTA offers stud ball bumping (SBB) flip-chip assembly of prototypes. On one project, subsequent electrical testing indicated an open joint. X-ray inspection pinpointed a bump with a possible

missing connection. Cross-sectioning of an IC sample then performed for further analysis of the problem. It found that the root cause was due to poor planarity in the die-placement and pre-curing process (fig. 4).

FIG. 4 Views showing the open flip-chip interconnect as seen by X-ray inspection (top) and optical visual inspection of a cross-section.

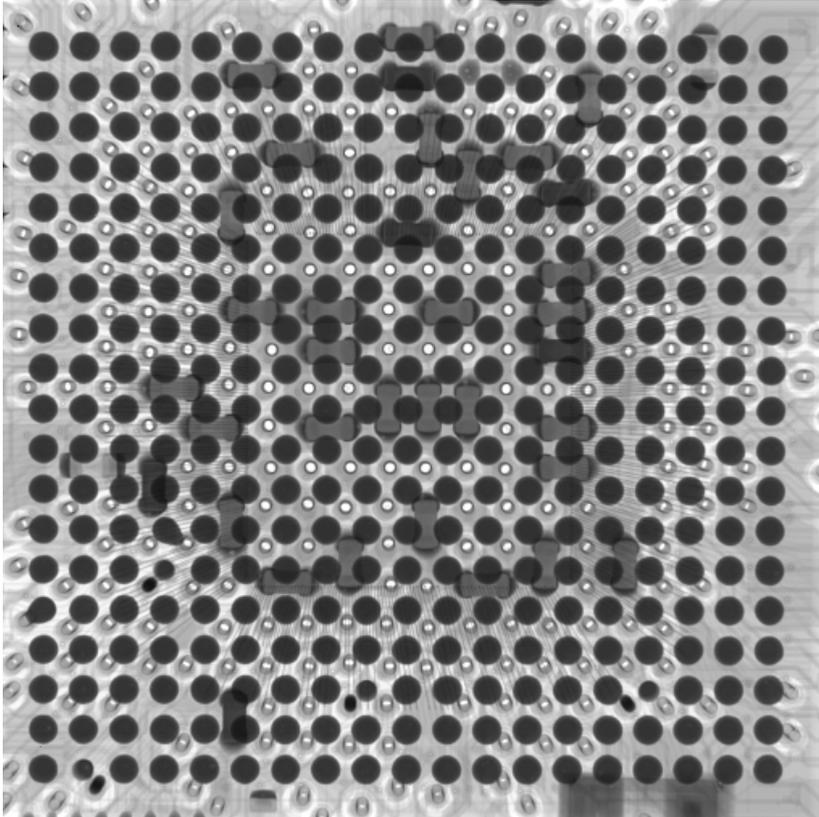
was seen to have moved from the BGA joint position towards vias located in the centre of four similar joints - see the typical X-ray view (fig. 5). Destructive Physical Analyses (DPA) demonstrated a problem with vias acting as solder 'thieves' in the BGA, due to poor coverage of the solder resist coating on some lots (fig. 6)

FIG. 5 X-ray view of the BGA solder joints. Notice the tendency to solder movement away from the intended joints and towards vias.

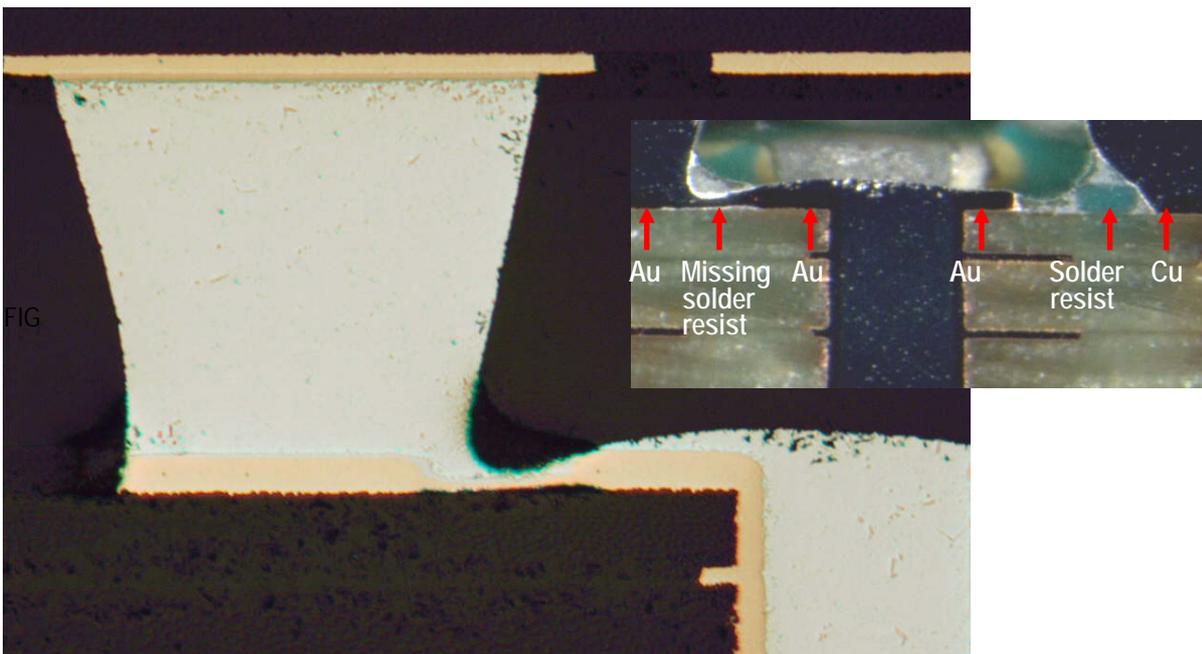
FIG. 6 Optical view of a device cross section at the position pinpointed by X-ray examination. Notice the via acting as a solder 'thief', caused by missing solder resist.
