# SEM analysis reveals real cause of chip failure

*Trouble-shoot problems quickly to save time*

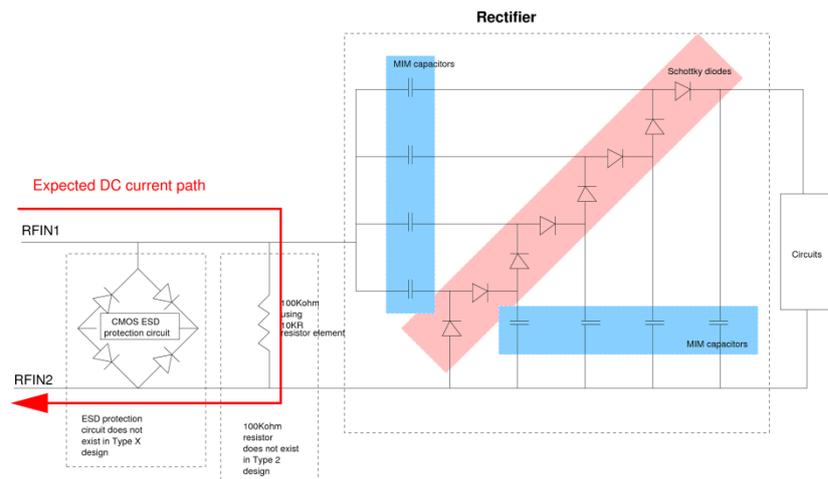
The actual circuit between RFIN1 and RFIN2 is shown in fig. 1. The ASIC was made in three different design variants, type 1, 2 and X. Note that ESD protection circuit does not exist in type X design. Further the 100 KΩ resistor does not exist in the type 2 design.

FIG. 1 The circuit between RFIN1 and RFIN2. Modulator and demodulator circuits are not shown for the sake of simplicity.

The small misalignment of metal 4 also explained another issue found during the debug of the prototypes. The performed electrical measurements pinpointed a poly silicon resistor (fig. 1 – type 1 and X) to be open/not processed.

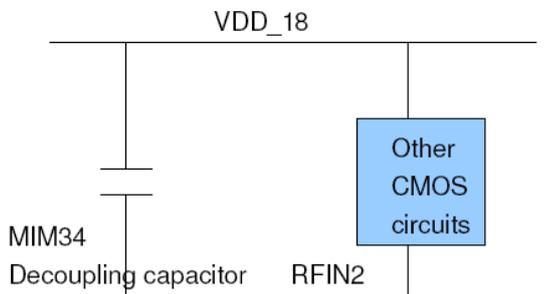
The circuit between VDD18 and RFIN2 is shown in fig. 2. This part of the design is the same for all three design variants.

FIG. 2 A drawing of the circuit between VDD\_18 and RFIN2.

Fig. 2 shows that there is a MIM decoupling capacitor between VDD18 and RFIN2. Again a short of this MIM capacitor will explain the obtained results of measurements on the prototypes.
